# COMMUNITY INSPECTION REPORT – AYLESHAM CENTRE, PECKHAM

Project Reference: CIR-2026-001

Friday, 17 July 2026

Responsible Authority Independent Community Inspection

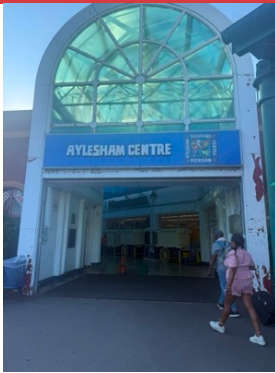
## **MAIN ENTRANCE – GENERAL CONDITION AND PUBLIC ENVIRONMENT**

This photograph shows the principal public entrance to the Aylesham Centre and provides context for the inspection. The entrance serves a high volume of visitors accessing retail units and public facilities. Subsequent observations identify defects affecting the overhead bird-control system, cleanliness and maintenance within the shopping centre. Given the level of public use, the condition of these areas should be maintained to a high standard.

Continue routine inspections of the main entrance and adjoining public areas, ensuring identified maintenance issues relating to bird-control systems, cleanliness and associated infrastructure are addressed promptly to maintain a safe, clean and welcoming environment.

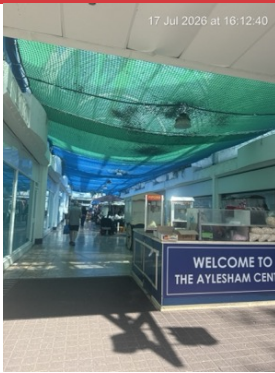
## **BIRD-CONTROL NETTING ABOVE FOOD RETAIL AREAS**

Bird fouling has accumulated within the overhead bird-control netting directly above food kiosks, retail units and a busy public walkway. Although no active contamination of food was observed during this inspection, the position and extent of the fouling create a potential hygiene concern and require urgent assessment. The condition of the netting suggests that the current bird-control system is not being adequately maintained and may no longer be effective. Centre management should ensure that food businesses operating beneath the affected area are not exposed to contamination and that the matter is referred to Environmental Health if any contamination of food, equipment or preparation surfaces is identified.

Arrange an urgent inspection of the overhead bird-control system and the food-trading areas beneath it. Remove accumulated bird fouling and debris using an appropriate specialist contractor, repair or replace defective sections of netting, inspect all fixings and lighting, and confirm that food, equipment and preparation areas have not been contaminated. Introduce a planned cleaning and maintenance programme and suspend use of any affected food area temporarily if an immediate contamination risk is identified.

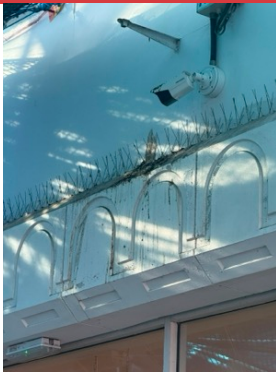
## **BIRD FOULING BENEATH BIRD DETERRENT SPIKES**

Bird fouling is visible beneath the installed bird deterrent spikes above the public walkway and retail frontage. The staining suggests birds are continuing to perch or access the area despite the deterrent measures. The accumulation of fouling affects the cleanliness and appearance of the shopping centre and indicates that the existing bird-control measures should be reviewed for effectiveness.

Clean and disinfect the affected surfaces using an appropriate contractor, inspect the bird spikes to ensure they are correctly installed and effective, replace or extend the deterrent system where necessary, and implement routine inspections and cleaning to prevent further accumulation of bird fouling.

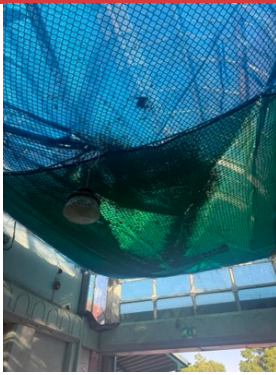
## **FAILED AND SAGGING BIRD-CONTROL NETTING**

The bird-control netting is visibly damaged and has sagged significantly, creating a large unsupported section above a public pedestrian route and occupied retail units. The failure compromises the effectiveness of the bird-deterrent system, allowing the accumulation of debris and increasing the potential for bird nesting and fouling. The condition also indicates deterioration of the support system and requires prompt inspection and remedial action.

Carry out an urgent inspection of the bird-control netting and all supporting fixings. Repair or replace the failed section, remove any accumulated debris and nesting material where legally permitted, inspect the entire bird-control system for similar defects, and implement a planned maintenance programme to ensure the system remains safe and effective.

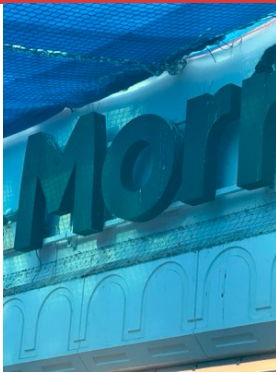
## **BIRD NESTING AND FOULING ABOVE MORRISONS SIGNAGE**

Evidence of bird nesting and accumulated bird fouling above the Morrisons signage. The presence of nesting material indicates that the current bird-control measures are ineffective in this location. Continued bird activity is likely to increase fouling of the signage and surrounding surfaces, affecting cleanliness, presentation and increasing maintenance requirements. Inspection and remedial works are recommended to remove nesting material and improve the effectiveness of the bird-deterrent system.

Remove nesting material in accordance with wildlife legislation where permitted, thoroughly clean affected surfaces, inspect and repair the bird-control netting and deterrent measures, and implement a routine inspection and maintenance programme to prevent recurrence.

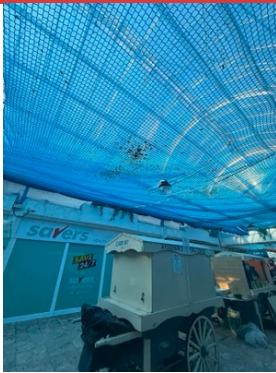
## **BIRD FOULING WITHIN OVERHEAD BIRD-CONTROL NETTING**

Localised accumulations of bird fouling are visible within the overhead bird-control netting above the public walkway, market stalls and retail units. The build-up indicates ongoing bird activity and suggests the netting is not being routinely inspected and cleaned. The condition detracts from the appearance of the shopping centre and raises hygiene and maintenance concerns in a busy public area.

Arrange a specialist inspection and cleaning of the overhead bird-control netting and surrounding structure. Remove accumulated bird fouling and debris, inspect the netting and fixings for defects, undertake any necessary repairs, and introduce a planned inspection and maintenance schedule to maintain the effectiveness of the bird-control system.

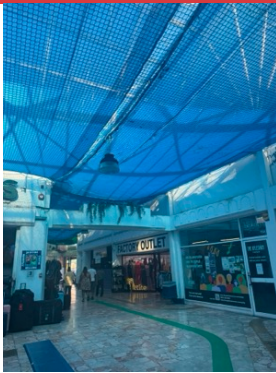
## **CONDITION OF OVERHEAD BIRD-CONTROL NETTING SYSTEM**

A general inspection of the overhead bird-control netting identified sections of sagging netting together with visible accumulations of debris and vegetation. The condition indicates that parts of the bird-control system require inspection and maintenance to ensure they remain effective and presentable above a busy public walkway and retail environment.

Undertake a comprehensive inspection of the entire overhead bird-control system, remove accumulated debris, repair or replace any defective sections of netting and fixings, and implement a planned inspection and maintenance programme to maintain the system's effectiveness and appearance.

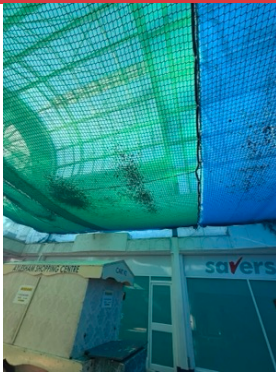
## **WIDESPREAD BIRD FOULING WITHIN OVERHEAD NETTING**

Multiple accumulations of bird fouling are visible within the overhead bird-control netting above the public walkway, market stalls and retail units. The widespread distribution of fouling suggests ongoing bird activity across a larger section of the bird-control system rather than an isolated area. The condition affects the cleanliness and presentation of the shopping centre and indicates that routine inspection and maintenance of the netting may be required.

Undertake a full inspection of the affected section of bird-control netting, remove accumulated bird fouling and debris using appropriate specialist cleaning methods, assess the effectiveness of the current bird-deterrent system, repair or replace defective sections where necessary, and implement a scheduled inspection and maintenance programme to reduce future accumulation.

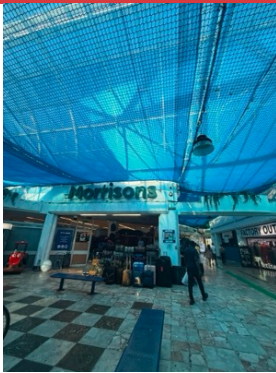
## **EXTENT OF OVERHEAD BIRD-CONTROL SYSTEM ABOVE MAIN PUBLIC WALKWAY**

This image provides an overview of the overhead bird-control netting above the main pedestrian route and retail units, including the Morrisons entrance. It demonstrates the location and extent of the bird-control system in a high-footfall area and provides context for the specific defects identified elsewhere in this report, including damaged netting, accumulated bird fouling and maintenance concerns.

Carry out a comprehensive inspection of the entire overhead bird-control system serving the main public walkway and retail units, ensuring all sections are maintained to a consistent standard and any identified defects are repaired promptly.

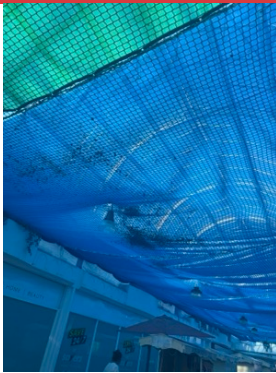
## **ACCUMULATION OF DEBRIS WITHIN BIRD-CONTROL NETTING**

Bird-control netting contains a significant accumulation of leaves, nesting material and other debris. This indicates that the netting is not being routinely inspected or maintained. The build-up reduces the effectiveness of the bird-deterrent system, may encourage further bird activity, and detracts from the overall appearance of the shopping centre. A planned maintenance regime should be implemented to remove debris and maintain the integrity of the netting.

Carry out a full inspection of the bird-control netting, remove all accumulated debris and nesting material (where legally permitted), repair or replace any damaged sections, inspect all fixings, and introduce a scheduled inspection and maintenance programme to prevent future build-up.

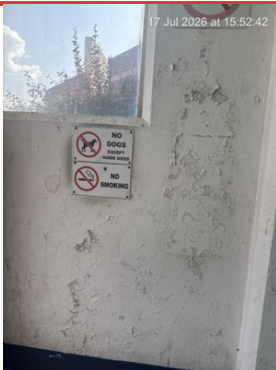
## **DETERIORATED DECORATIVE**

Decorative wall finishes at the main entrance and adjoining public areas are deteriorating, with extensive flaking paint, peeling coatings and weathered surfaces. The condition detracts from the appearance of the shopping centre and suggests that external decorations are overdue for maintenance.

Prepare affected surfaces, remove loose paint, repair damaged areas and redecorate using suitable external-grade coatings. Introduce a planned cyclical decorating programme.

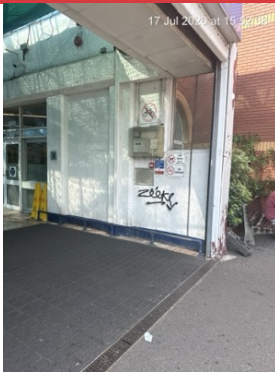
## **GRAFFITI ON ENTRANCE WALL**

Graffiti is present on the entrance wall adjacent to the public access route. The vandalism negatively affects the appearance of the shopping centre and, if left untreated, may encourage further graffiti.

Remove graffiti using appropriate cleaning methods and apply an anti-graffiti coating where appropriate. Monitor and remove future graffiti promptly.

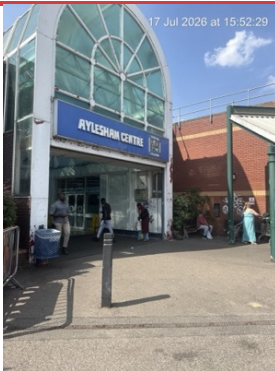
## **EXECUTIVE SUMMARY AN INDEPENDENT COMMUNITY INSPECTION OF THE AYLESHAM CENTRE**

An independent community inspection of the Aylesham Centre was undertaken on 17 July 2026 to assess the condition of public areas, maintenance standards and environmental issues affecting visitors, traders and businesses.

- deterioration of the overhead bird-control system
- significant accumulations of bird fouling, debris and nesting material
- potential hygiene concerns above food retail areas
- deteriorated decorative finishes and external paintwork
- graffiti affecting the appearance of the main entrance.

The Aylesham Centre remains a busy and valuable community shopping destination. However, the inspection identified several maintenance and environmental issues requiring attention, particularly the condition of the overhead bird-control system and the accumulation of bird fouling above public walkways, market stalls and food retail areas.

A coordinated programme of inspection, specialist cleaning, repair and planned maintenance is recommended. Addressing these issues promptly would improve public confidence, support the businesses operating within the centre, enhance its appearance and reduce the likelihood of further deterioration and higher future maintenance costs.
