# ESTATE SAFETY & MAINTENANCE INSPECTION – COMMUNAL AREAS

ED-CHA-200726-01

Monday, 20 July 2026

Responsible Authority Hyde Housing Association

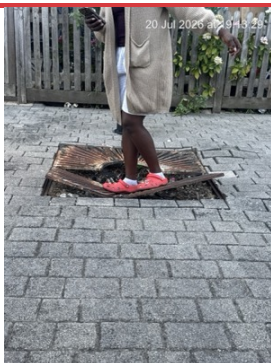
## **COLLAPSED TREE GRILLE RISKY RATING: ● HIGH**

The protective cast iron tree grille has become detached from its frame and collapses when weight is applied.

The inspection demonstrated movement under normal body weight.

- \* Trip hazard
- \* Entrapment hazard
- \* Cuts from exposed metal
- \* Injury to children
- \* Injury to elderly residents
- \* Wheelchair and pushchair instability
- \* Potential public liability claim

- \* Fence off affected area.

- \* Install temporary warning barriers.
- \* Inspect remaining tree grilles.

- \* Replace damaged tree grille.
- \* Inspect fixing frame.
- \* Introduce annual inspections of all tree pits.

Immediate (24–48 hours)

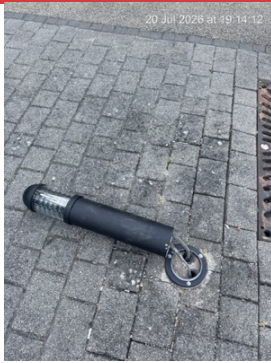
**1X LIGHTING BOLLARD WAS FOUND DETACHED FROM ITS BASE. RISKY RATING: HIGH**

The unit appeared to have been removed from its fixing leaving exposed mounting points.

- \* Possible electrical hazard
- \* Trip hazard
- \* Reduced visibility
- \* Vandalism risk

- \* Isolate electrical supply if required.
- \* Electrical inspection by qualified engineer.
- \* Replace damaged fixing.
- \* Test illumination after repair.

Immediate

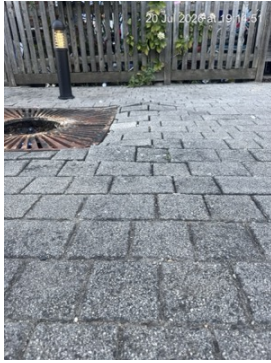
**UNEVEN BLOCK PAVING CREATING TRIP HAZARD RISK RATING: MEDIUM**

During the inspection, sections of the block paving were found to be uneven and have visibly settled, creating an irregular walking

surface within a communal pedestrian area.

This defect presents a foreseeable risk of trips and falls, particularly for:

If left unaddressed, the defect is likely to worsen due to continued pedestrian use and adverse weather conditions, increasing the likelihood of accidents and potential liability.

- \* Inspect the affected paving.
- \* Lift and relay the uneven block paving to restore a level surface.
- \* Replace any damaged or sunken sub-base materials where necessary.
- \* Inspect the surrounding paving for signs of further settlement.
- \* Include this area within future planned maintenance inspections.

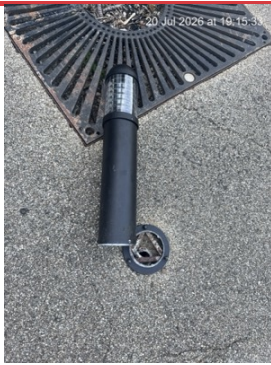
**1X LIGHTING BOLLARD WAS FOUND DETACHED FROM ITS BASE. RISK RATING: ● HIGH**

The unit appeared to have been removed from its fixing leaving exposed mounting points.

- \* Possible electrical hazard
- \* Trip hazard
- \* Reduced visibility
- \* Vandalism risk

- \* Isolate electrical supply if required.
- \* Electrical inspection by qualified engineer.
- \* Replace damaged fixing.
- \* Test illumination after repair.

Immediate

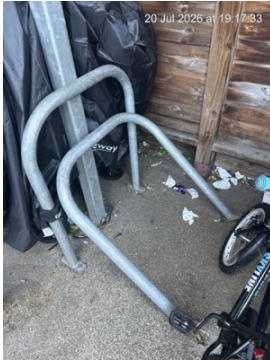
**DAMAGED CYCLE STAND – BENT AND UNSAFE RISK RATING: ● HIGH**

During the inspection, the communal cycle stand was found to be significantly bent and no longer in its intended position. The

damage appears consistent with either impact damage or prolonged structural deterioration.

The condition of the cycle stand reduces its effectiveness for securely storing bicycles and presents a foreseeable health and safety risk. The protruding metal frame may create a trip hazard and could cause injury to residents, particularly children who regularly play within the communal area.

The surrounding area also contains litter and discarded waste, which detracts from the appearance of the estate and may encourage vermin if not routinely cleared.

- \* Inspect the cycle stand to determine whether repair is feasible or replacement is required.
  - \* Remove or make safe any protruding or unstable metal components without delay.
  - \* Ensure the replacement stand is securely fixed in accordance with the manufacturer's specification.
  - \* Remove litter from the surrounding area and review the cleaning schedule.
  - \* Inspect all cycle stands across the estate for similar damage.
-

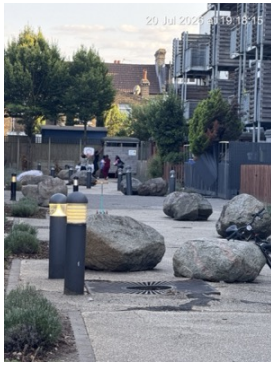
## **SHARED PLAY AND CYCLE ROUTE – COLLISION AND IMPACT HAZARDS 🟡 MEDIUM–HIGH**

This communal route is regularly used by children for playing, cycling and riding scooters. Several large fixed boulders, lighting bollards, tree surrounds and other hard landscape features are positioned within or immediately beside the route.

Although these features may have been installed for landscaping or vehicle control, the current arrangement creates a foreseeable risk of children colliding with hard objects, particularly when cycling at speed, playing in groups or using the area during poor light conditions. The nearby damaged tree grille and previously displaced lighting bollard further increase the overall risk.

Hyde should assess whether this area is intended or commonly used as an informal play space and whether the present layout remains suitable and safe. The Occupiers' Liability Act 1957 requires reasonable care to ensure visitors are reasonably safe, while the HHSRS recognises collision, entrapment and fall hazards within residential environments.

- \* Complete a formal child-safety and communal-area risk assessment.
- \* Inspect the positioning and stability of all boulders, bollards, tree grilles and street furniture.
- \* Repair all damaged lighting and tree surrounds immediately.
- \* Improve lighting and visibility along the route.
- \* Consider creating a clearly designated, unobstructed area for children to cycle and play.
- \* Consider protective edging, repositioning hazards or introducing visual markings where removal is unsuitable.
- \* Introduce regular recorded inspections and resident reporting arrangements.
