Elijah Decimus Community Projects & Local Advocacy

# COMMUNITY CLEANLINESS INSPECTION – LEE HIGH ROAD, LEWISHAM (

LHR-CCI-220726

Wednesday, 22 July 2026

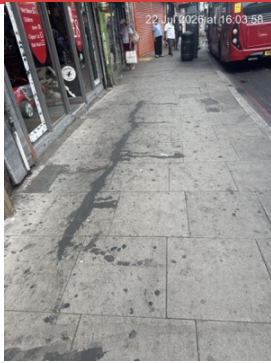
## **HEAVY LIQUID STAINING AND INGRAINED PAVEMENT GRIME**

A long trail of dark liquid residue and heavy staining was observed extending from the shopfront area across several paving slabs along the pedestrian route. The pavement is also covered with widespread splash marks and ingrained grime.

The source of the liquid could not be confirmed during the inspection. However, its position and pattern suggest that it may be connected to activity from nearby commercial premises.

The affected area requires a thorough mechanical or pressure clean. The council should also investigate whether wastewater, grease or other substances are being discharged onto the public footway and take appropriate enforcement action where responsibility is established.

Arrange a targeted deep clean using hot-pressure washing or suitable mechanical pavement-cleaning equipment to remove the ingrained staining and residue. Inspect nearby commercial premises to identify the source of the liquid, remind businesses that wastewater and grease must not be discharged onto the public footway, and take enforcement action where evidence supports it. Add this section to a monitored cleansing schedule with a follow-up inspection to confirm that the staining has been removed and has not returned.

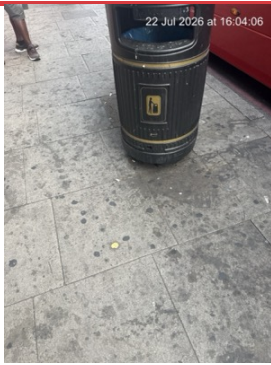
## **HEAVILY STAINED PAVEMENT AROUND PUBLIC LITTER BIN**

The paving surrounding the public litter bin was heavily marked by dark liquid splashes, ingrained grime and surface staining. Dirt and residue were particularly concentrated around the base of the bin, suggesting that this area is not being cleaned thoroughly during routine street-cleansing visits.

The bin itself appears available for use, but the surrounding pavement remains visibly dirty and detracts from the appearance of the wider shopping area.

Remove any loose litter and carry out a detailed hot-pressure or mechanical clean around the full base of the bin and the surrounding paving slabs. The exterior and underside of the bin should also be washed. Add the area around public bins to routine targeted cleansing checks, with periodic deep cleaning to prevent repeated build-up of grime and liquid residue.

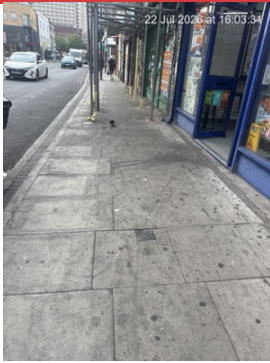
## **HEAVILY SOILED PAVEMENT BENEATH SHOPFRONT SCAFFOLDING**

The footway beneath and alongside the shopfront scaffolding was visibly covered with widespread dark spotting, ingrained dirt, residue and scattered debris. The staining extends across the pedestrian route and is particularly noticeable close to the shop entrance and around the scaffold bases.

The presence of scaffolding may make routine mechanical cleansing more difficult, but the pavement must still be maintained to an acceptable standard. The narrow walking route and dirty surface also reduce the quality of the pedestrian environment.

Arrange a detailed manual clean followed by suitable mechanical or hot-pressure washing where access permits. Clean around every scaffold base, shopfront edge and utility cover rather than only the open central route. Confirm whether the business or scaffolding contractor has cleansing obligations, require any associated waste or residue to be removed, and inspect the area again while the scaffolding remains in place.

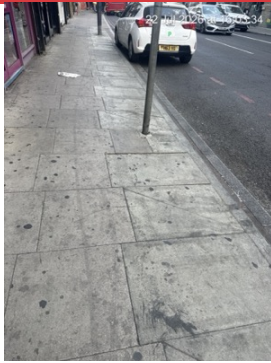
## **WIDESPREAD PAVEMENT STAINING, LITTER AND INGRAINED GRIME**

A substantial section of the footway was visibly covered with dark splash marks, ingrained grime, scuffing and general surface staining. A discarded item of litter was also present along the pedestrian route.

The condition extends across numerous paving slabs and is not limited to one small patch. Although the exact source of the staining could not be confirmed during the inspection, the repeated marks and overall appearance suggest that routine sweeping is not sufficient to maintain this section of Lee High Road to an acceptable standard.

Remove the loose litter and arrange a full-width mechanical or hot-pressure clean of the affected pavement, including the kerb edge and areas around the street pole. Review the frequency and quality of scheduled cleansing along this commercial stretch. Where fresh staining appears linked to nearby businesses, investigate the source and provide advice or enforcement as appropriate. Carry out a follow-up inspection after cleaning to ensure the condition has improved.

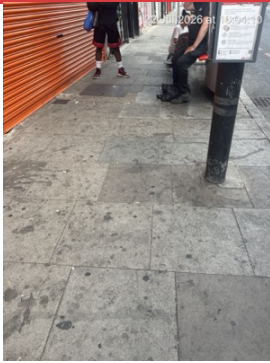
## **DIRTY AND STAINED FOOTWAY AROUND BUS STOP AREA**

The pavement around the bus stop was visibly affected by widespread dark staining, ingrained dirt, scattered residue and small pieces of litter. Grime was also concentrated around the base of the bus-stop pole and along the edge of the closed shopfront.

As this is a high-footfall waiting area, the current condition creates a poor impression for passengers and pedestrians. The repeated staining suggests that ordinary sweeping is not sufficient and that detailed washing is required.

Remove all loose litter and carry out a full-width mechanical or hot-pressure clean of the pavement, including the area around the bus-stop pole, seating, kerb edge and shopfront boundary. Clean the street furniture where necessary and introduce regular targeted inspections of the bus-stop area, particularly during periods of heavy use.

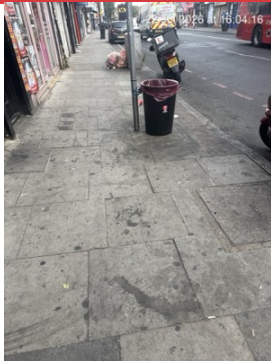
## **POORLY MAINTAINED FOOTWAY WITH STAINING, LITTER AND REFUSE BAGS**

The footway was visibly affected by widespread dark staining, ingrained grime and scattered litter. Although a public litter bin is present, the surrounding paving remains dirty and marked.

Several refuse bags were also visible further along the pavement beside street infrastructure. This indicates a combined issue involving inadequate detailed cleansing and potentially incorrect presentation of commercial waste.

Remove the refuse bags and loose litter, then carry out a full-width hot-pressure or mechanical clean of the pavement, including around the litter bin, street poles, utility covers and kerb edge. Establish who placed the refuse bags there and take enforcement action where commercial waste has been presented incorrectly. Increase cleansing and waste-monitoring visits along this section and complete a follow-up

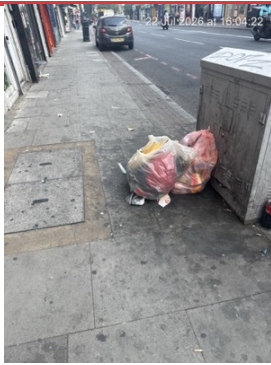
## **COMMERCIAL REFUSE BAGS OBSTRUCTING AND FOULING THE PUBLIC FOOTWAY**

Two large refuse bags containing mixed waste were left directly on the public pavement beside a utility cabinet. Loose waste was also visible around the bags, and the surrounding paving was heavily stained and dirty.

The bags reduce the usable width of the footway and create an unattractive and potentially unhygienic environment for pedestrians. Their contents and location suggest that they may be connected to a nearby commercial premises, although responsibility could not be confirmed during the inspection.

Arrange prompt removal of the refuse and clean the affected paving and utility-cabinet surroundings. Inspect the bags for evidence identifying the waste producer, review nearby CCTV where available, and confirm whether the waste was placed out within an authorised collection period. Where commercial waste has been presented incorrectly, issue appropriate advice or enforcement. Introduce targeted waste-presentation checks along this stretch of Lee High Road.

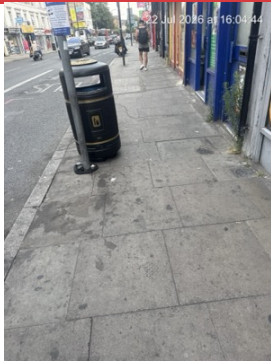
## **STAINED PAVEMENT, WEEDS AND POOR CLEANSING AROUND STREET FURNITURE**

The pavement was visibly affected by widespread dark staining, splash marks and ingrained grime, particularly around the public litter bin, signpost and kerb edge. Weeds were also growing from the edge of the shopfront and around drainage or utility features.

Although a litter bin is available, the surrounding area remains poorly maintained. Dirt and vegetation have accumulated in areas that may be missed during routine sweeping, reducing the overall cleanliness and appearance of the pedestrian route.

Remove the weeds and loose debris, clean around the full base of the litter bin, signpost, kerb and shopfront edge, and carry out a full-width mechanical or hot-pressure wash of the affected paving. The council should include edges, utility covers and street-furniture bases within future cleansing inspections and investigate any recurring liquid staining linked to nearby premises.

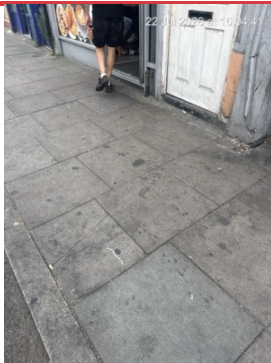
## **FOOD-PREMISES FRONTAGE AFFECTED BY INGRAINED STAINING AND RESIDUE**

The paving immediately outside the commercial entrance was visibly affected by dark spots, ingrained grime, splash marks and small areas of residue. Dirt had also accumulated along the doorway and building edge.

Because the staining is concentrated beside the entrance to a food premises, the source should be checked rather than assumed. The condition may result from customer activity, waste handling, food or drink spillages, or inadequate cleaning of the shop frontage.

Deep-clean the pavement outside the entrance, including the doorway, kerb edge and building line. The council should inspect the premises' waste-handling and frontage-cleaning arrangements and confirm whether any liquids or food residue are being allowed onto the public footway. Require the business to clean any mess for which it is responsible and take enforcement action if repeated fouling is established.

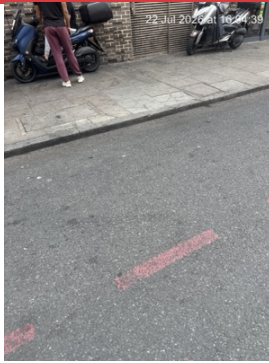
## **FADED AND UNCLEAR CARRIAGEWAY / BUS-LANE MARKINGS**

The carriageway markings visible in this section appear faint, worn and insufficiently clear. The pink/red bus-lane style markings are patchy and no longer stand out clearly against the road surface. This reduces the visual clarity of the highway layout for drivers and weakens the overall appearance of the street.

Although the footway in this image is the main foreground, the adjoining road markings are also relevant to the condition of the wider public realm and may require renewal.

Inspect the condition of the carriageway markings and confirm whether repainting or full remarking is required. Refresh any faded bus-lane or traffic-management markings so they are clear, consistent and easily visible to road users. Where old or redundant markings remain, remove or properly replace them to avoid confusion, and include the location in future highway-condition inspections.

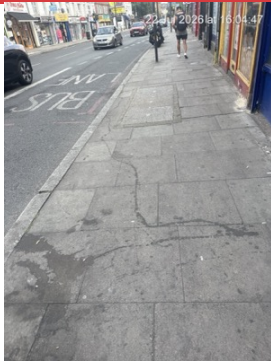
## **EXTENSIVE LIQUID TRAILS AND INGRAINED STAINING ACROSS FOOTWAY**

Several long liquid trails, splash marks and dark stained patches were visible across the pedestrian route. The residue extends over multiple paving slabs and appears to run from the shopfront side of the pavement towards the kerb.

The exact source could not be confirmed during the inspection. However, the pattern suggests repeated spillages, washing water or another form of liquid discharge rather than ordinary footfall alone. The surrounding paving is also affected by widespread ingrained grime and scattered small debris.

Arrange a full-width hot-pressure or mechanical deep clean of the affected pavement, including the shopfront edge, kerb line and utility cover. Investigate nearby businesses to determine whether washing water, grease or other liquids are being discharged onto the public footway. Require responsible premises to improve their cleaning and waste-handling practices, use enforcement where repeated fouling is established, and reinspect the location after cleansing.

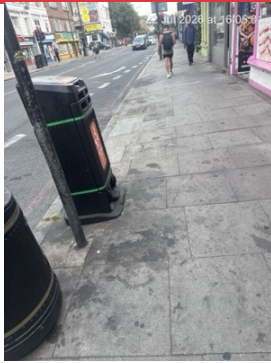
## **HEAVILY STAINED PAVING AROUND BINS AND STREET FURNITURE**

The pavement around the public litter bin, larger street bin and adjoining pole was visibly affected by extensive dark staining, ingrained grime and dirt concentrated around the bases of the street furniture. Similar marks continue along the pedestrian route.

The clustering of dirt around fixed equipment suggests these areas may be missed during routine sweeping. The condition weakens the overall appearance of this busy commercial section of Lee High Road.

Carry out a detailed mechanical or hot-pressure clean around the full bases of both bins, the pole, kerb edge and surrounding paving slabs. Wash the exterior of the street furniture where necessary and remove any trapped litter or residue. Future cleansing inspections should specifically include fixed equipment and other hard-to-reach areas, followed by a recorded reinspection to confirm improvement.

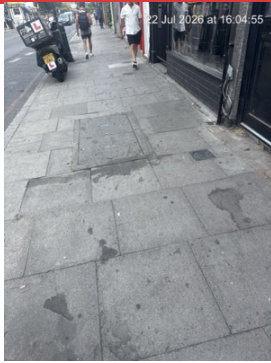
## **REPEATED LIQUID STAINING AND GRIME OUTSIDE COMMERCIAL PREMISES**

Several dark liquid patches, splash marks and areas of ingrained grime were visible across the footway immediately outside the commercial frontage. Dirt and debris had also accumulated along the doorway and building edge.

The repeated pattern of staining across separate paving slabs suggests recurring spillages, wastewater or another form of liquid discharge rather than a single isolated incident. However, the precise source could not be confirmed during the inspection.

Carry out a full-width hot-pressure or mechanical deep clean, including the shopfront edge, doorway, utility covers and kerb line. Investigate nearby businesses' frontage-cleaning, waste-handling and wastewater arrangements. Require any responsible premises to prevent further discharge onto the public footway, use enforcement where repeated fouling is established, and reinspect the area after cleansing.

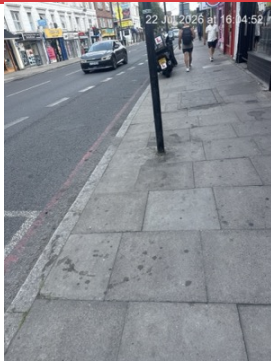
## **WIDESPREAD PAVEMENT STAINING ALONG BUSY COMMERCIAL FOOTWAY**

The pavement was visibly affected by repeated dark spots, splash marks and ingrained grime across a substantial section of the pedestrian route. Staining was present close to the kerb, around the street pole and along the shopfront side of the footway.

The marks continue over numerous paving slabs, showing that the problem is not confined to one isolated patch. The condition contributes to the generally neglected appearance of this busy section of Lee High Road.

Carry out a full-width mechanical or hot-pressure clean of the pavement, including the kerb edge, street-pole base and shopfront boundary. Investigate whether recurring staining is linked to nearby commercial activity, improve the frequency of detailed cleansing along this stretch and complete a follow-up inspection after the work.

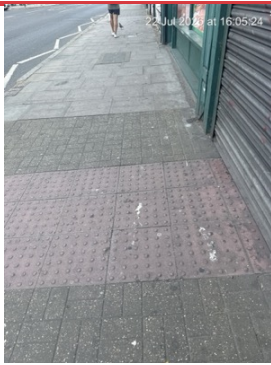
## **SOILED AND STAINED TACTILE PAVING AT PEDESTRIAN CROSSING**

The tactile paving at the pedestrian crossing was visibly affected by dark spotting, white residue, ingrained dirt and surface staining. Because tactile paving is specifically used by blind and partially sighted pedestrians, it should be kept clean, unobstructed and clearly distinguishable from the surrounding footway.

The staining also continues onto the adjacent paving and close to the shopfront edge, indicating that this is part of the wider cleanliness problem along Lee High Road.

Carry out a careful deep clean of the tactile paving and surrounding footway using a suitable method that will not damage the raised surface. Remove all residue from between the tactile studs, clean the shopfront edge and inspect the area for recurring discharge or spillages. Include tactile paving in future detailed cleansing inspections and arrange prompt follow-up where staining returns.

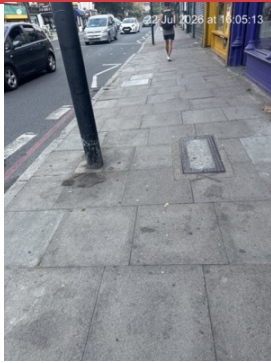
## **STAINED PAVEMENT AND NEGLECTED EDGES AROUND STREET POLE AND SHOPFRONTS**

The footway was affected by widespread dark staining, ingrained grime and scattered marks across numerous paving slabs. Dirt and residue were concentrated around the base of the street pole, while weeds and accumulated debris were visible along the shopfront edge.

These areas appear to be missed during routine sweeping and contribute to the wider neglected appearance of this section of Lee High Road.

Remove the weeds and accumulated debris, clean around the full base of the street pole, utility cover, kerb and building line, and carry out a full-width hot-pressure or mechanical wash of the paving. Future cleansing inspections should specifically include shopfront edges and the bases of fixed street furniture, followed by a recorded reinspection.

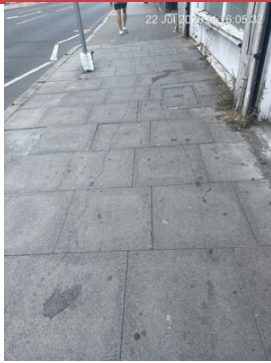
## **STAINED FOOTWAY WITH WEEDS AND DEBRIS ALONG NEGLECTED SHOPFRONT EDGE**

The pavement was visibly affected by dark staining, ingrained grime and scattered marks across multiple paving slabs. Weeds, dirt and accumulated debris were also present along the base of the adjoining building and around the utility cover.

The deteriorated shopfront edge and vegetation contribute to the neglected appearance of the area and suggest that the full width of the footway is not being cleaned during routine visits.

Remove the weeds and accumulated debris, clear the building edge and utility-cover surroundings, and carry out a full-width mechanical or hot-pressure clean of the paving. The adjoining property owner or occupier should be contacted where the frontage itself requires maintenance. Include shopfront edges and utility covers in future cleansing inspections and reinspect after the work is completed.

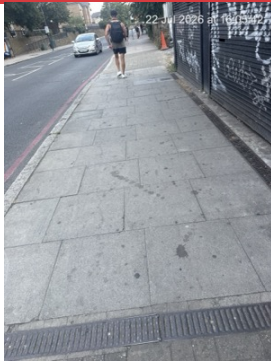
## **STAINED FOOTWAY AND NEGLECTED DRAINAGE CHANNEL BESIDE SHUTTERED PREMISES**

The pavement was affected by repeated dark splash marks, liquid staining and ingrained grime across several paving slabs. Dirt and debris were also visible along the linear drainage channel beside the shuttered commercial frontage.

The drainage edge and building line appear to be areas that may be missed during routine sweeping. The shutter itself is also heavily marked with graffiti, adding to the neglected appearance of this section.

Carry out a full-width mechanical or hot-pressure clean of the pavement and thoroughly clear the drainage channel, shopfront edge and kerb line. Check that the channel is free-flowing and not holding contaminated residue. Contact the property owner or occupier regarding graffiti removal and frontage maintenance, and include drainage edges in future detailed cleansing inspections.

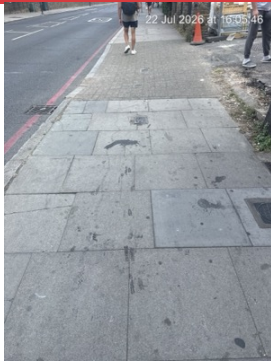
## **PAVEMENT STAINING, TRACK MARKS AND DEBRIS BESIDE WORKS AREA**

The footway was visibly affected by dark liquid staining, tyre or equipment track marks and ingrained dirt across several paving slabs. Loose soil, rubble and debris were also present along the edge of the adjoining works area.

The marks suggest that construction activity, equipment or materials may have been carried across the public footway. The surrounding area has not been adequately cleaned or contained, reducing the cleanliness and appearance of the pedestrian route.

Require the contractor or responsible property to remove all loose debris, contain the works area properly and clean any mud or residue deposited on the pavement. Carry out a full-width mechanical or hot-pressure clean of the affected slabs, including around utility covers and the kerb. Inspect the area during and after the works to ensure the footway remains clean, safe and unobstructed.
